PG-PLUS

TECHNICAL PRACTICE

3 POTS/1 ISDN CENTRAL OFFICE LINE UNIT

Model	List	CLEI Code
PLL-722	1	S9L1AC0A~~

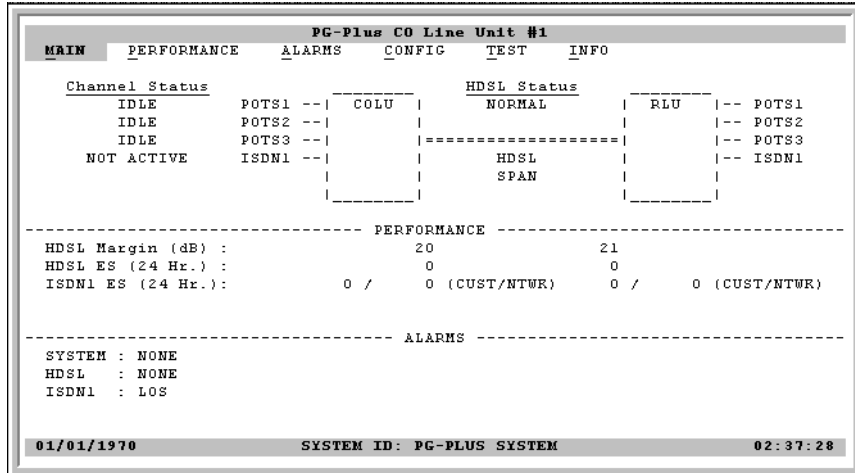
This screen details the performance condition of the COLU and RT.

Status indicators for the HDSL span and the POTS interfaces

HDSL performance summary in terms of margin and ES counts

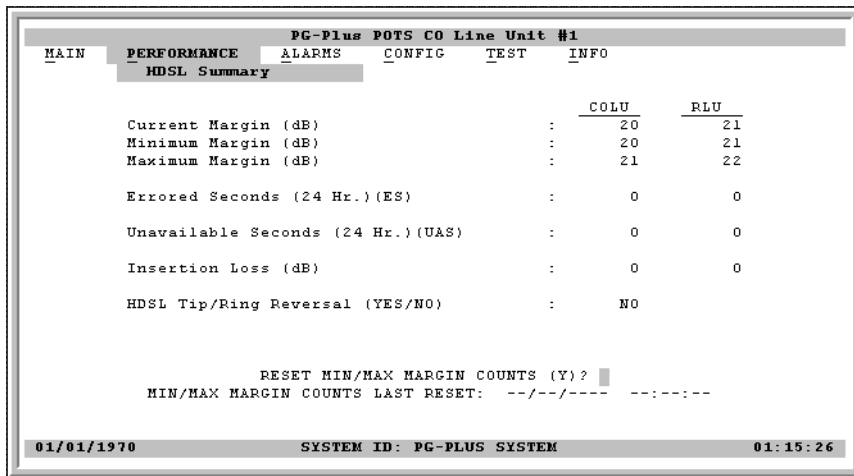
HDSL Summary Screen

This screen depicts an HDSL performance summary in terms of the MAR and ES count. Use the available options to reset the minimum and maximum margin counts.

The following performance parameters are reported:

- Margins: A measure of the ratio of signal power to noise power, in decibels (dB), at a receiver point.
 - Current Margin: The way the line looks now
 - Maximum Margin: The maximum value measured
 - Minimum Margin: The minimum value measured

- ES: An interval of 1 second during which at least 1 error is detected at the incoming HDSL port or there is an LOSW condition.
- UAS: An interval of 1 second during which a loop is down.
- Insertion Loss: dB measurement of signal loss

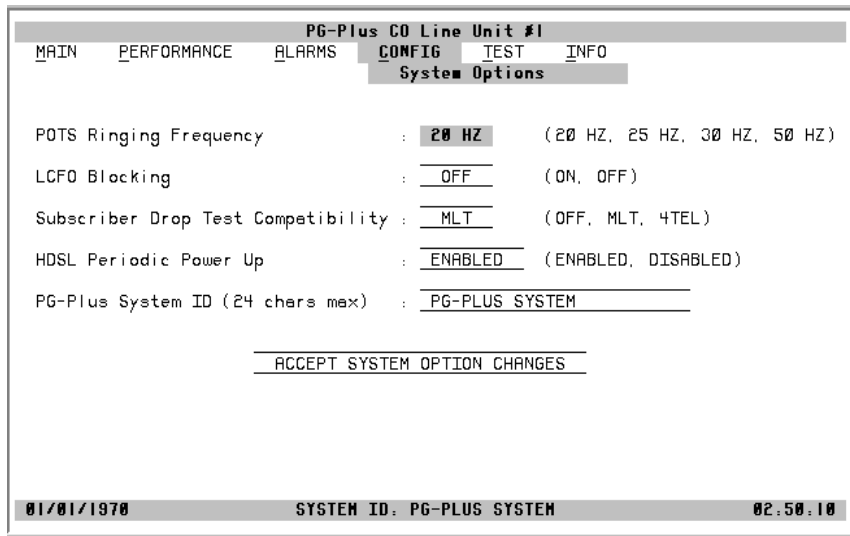
System Options Screen

Allows the provisioning of options such as ringing frequency, SDT, HDSL Periodic Power Up, and a System ID. [Table 6](#) shows the configured system data and their factory default value.

Options	Description	Default
POTS Ringing Frequency	The ringing frequency sent from the RLU to the subscriber. Possible values include 20 HZ, 25 HZ, 30 HZ, and 50 HZ.	20 Hz
LCFO Blocking	OFF, Detecting Removal of Battery command from CO causes RT to remove battery feed to the subscriber pair. ON, the detection of Removal of Battery command from CO does not cause the RT to remove battery feed to the subscriber pair.	Off
SDT Compatibility	Specifies whether the PG-Plus initiates and operates with MLT or 4TEL loop test systems. Possible values include Off, MLT, and 4TEL. Craft initiated drop tests work in any selection.	Off
HDSL Periodic Power Up	Enabled, PG-Plus in Metallic Fallback attempts to power up the HDSL line every five minutes or anytime the HDSL pair is shorted for two seconds and then opened. Disabled inhibits the power-up sequence under any circumstances and the system remains in Metallic Fallback.	Enabled

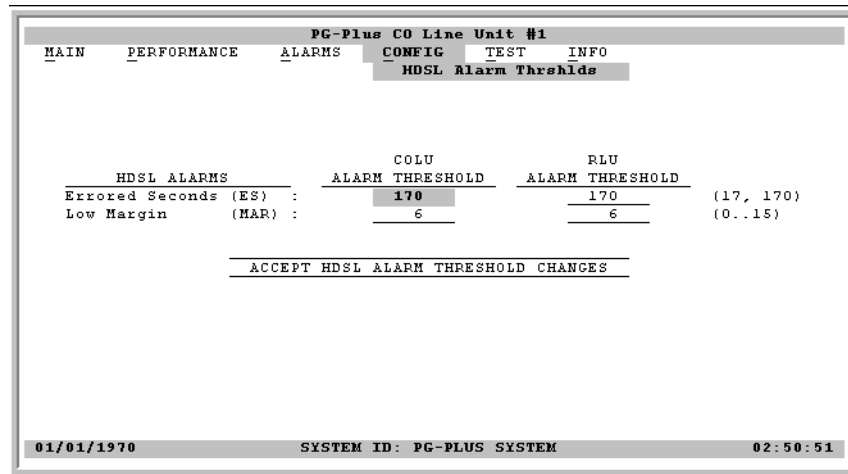
This screen is a means to provision the threshold crossing values for the 15 minute and 24-hour ES and UAS counts and low margin dB. Table 8 lists the fields of the HDSL Alarm Thresholds and the default factory values.

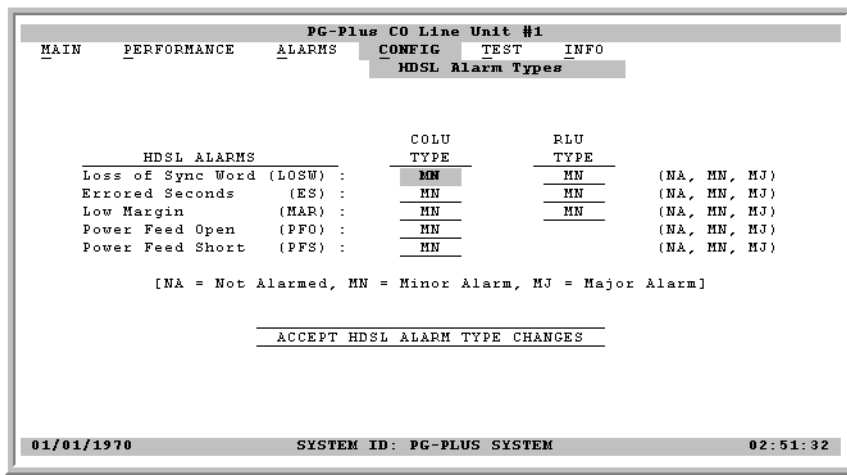
Allows the provisioning of the alarm types for all HDSL Alarms. [Table 9](#) lists the Alarm Reports and [Table 10](#) shows the HDSL Alarms, the possible alarm Types, and the default factory settings. You can view the results of these settings from the “HDSL History Screen” on page 21.

Alarm	Description	Default
LOSW	COLU cannot receive data over the given HDSL loop. COLU and RT cannot synchronize and is out of service.	MN
ES-15 Min.	Number of HDSL ES has exceeded the user-configurable threshold to give advance warning that HDSL performance is deteriorating. You can set this threshold from 0-15 ES over a 15-minute period, or disable the alarm completely. 24 hour ES alarm threshold reached or exceeded.	MN
ES-24 Hr.	Number of HDSL ES has exceeded the user-configurable threshold to give advance warning that HDSL performance is deteriorating. You can set this threshold from 0-255 ES over a 24-hour period, or disable the alarm completely. 24 hour ES alarm threshold reached or exceeded.	MN
MAR	HDSL noise margin of the loop has fallen below the user-configurable threshold. HDSL MAR reaches or drops below the current threshold value.	MN
PFO	COLU cannot power the RT due to an open circuit. An undercurrent condition as detected by the RT exists for the given pair (<20 mA). A possible cause is that there is no RT at the other end of the circuit. No user intervention is required.	MN

PFS	COLU cannot power the RT due to a short circuit. An excessive current condition as detected by the COLU exists for either pair (>50 mA). A PFS alarm indicates an overcurrent condition due to wire shorting or an RT failure. The COLU automatically turns off power feeding to both loops in response to a PFO or PFS condition on a single loop. No user intervention is required.	MN

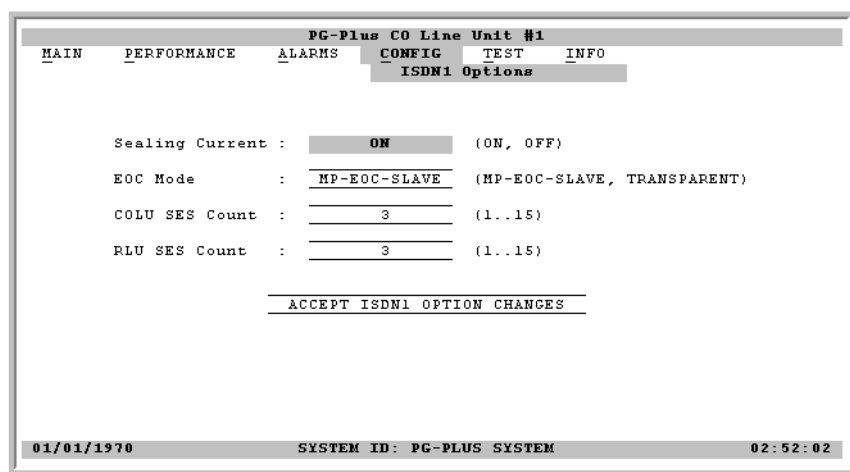
Provides access to configure the ISDN parameters. The values on the screen are the factory defaults. The Sealing Current fields allows the current to be turned On or Off between the RT and the CPE. The EOC Mode field allows the EOC processing type to be selected. The COLU and RT SES counts are the number of ISDN BE allowed before SES count is incremented.

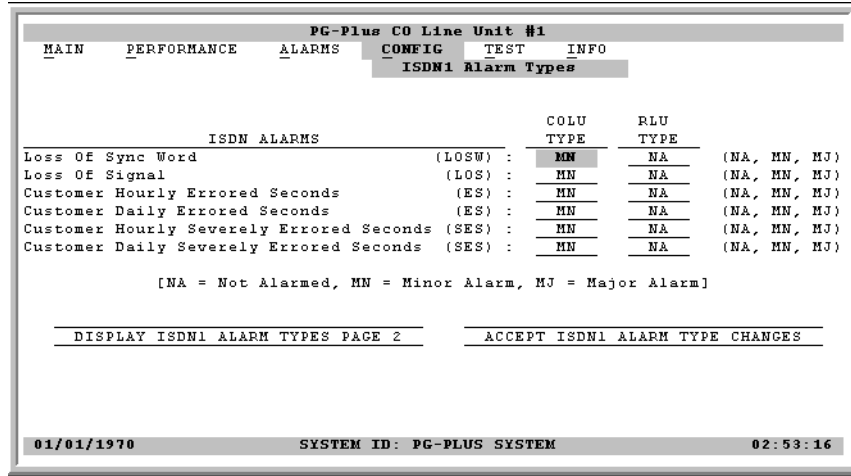
Allows the provisioning of the alarm types. Table 11 shows the ISDN Alarms, the possible alarm Types, and the default factory settings. All Alarm fields can be set to Major, Minor, or Not Alarmed.

Alarm	Description	Default
LOS	ISDN loss of signal condition at COLU and/or RT.	MN
LOSW	ISDN loss of SYNC word condition at COLU and RT.	MN
ES	ISDN hourly and/or daily ES count has reached or exceeded the configured value at COLU or RT.	MN
SES	ISDN hourly and/or daily SES count has reached or exceeded the value at the COLU or RT.	MN
DATA-TP-LO ST	An unusually high number of bit errors has been detected on the ISDN link at the COLU or RT.	MN
D+-LOSW	ISDN M-channel framing pattern has been lost on the HDSL link.	MN

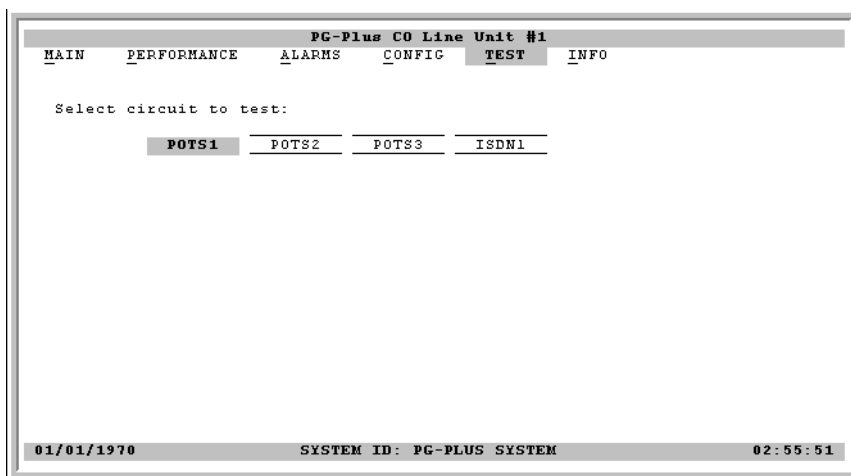
PG-Plus supports testing of a subscriber drop in two ways. A test can be initiated by applying a test voltage between the Tip and Ring at the COLU through an MLT test set, or by selecting it from the menu item through the VT-100 terminal connected to the PAU/PMU maintenance port. The relays in the COLU and RT provide a path for performing a SDT.

A warning displays when a channel is selected for the test.

Performing an SDT on one of the POTS or ISDN channel interrupts service on the line under test. The remaining lines on the PG-Plus system remains in service.

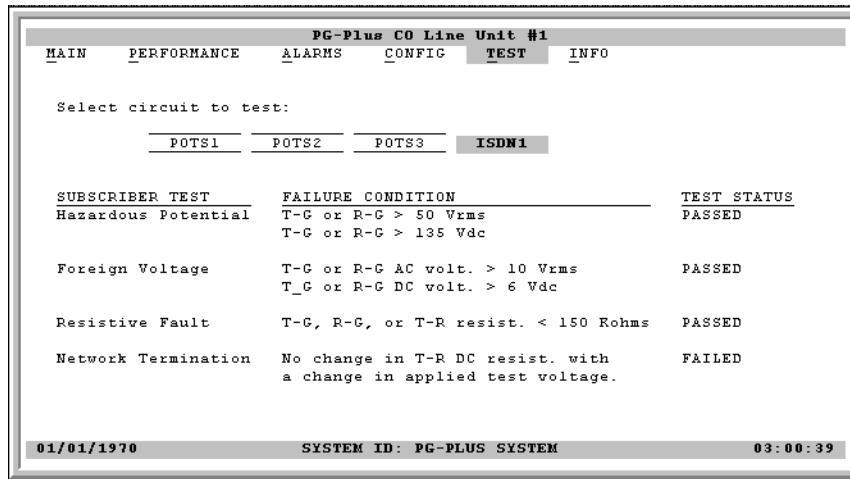
Upon tests completion the SDT Results screen displays Subscriber Test, Failure Condition, and Test Status. Tests are performed in the order of display. If a test fails, the remaining tests are not performed (as per TR-909). It takes approximately seven to eight seconds for all tests to complete.

If you selected the POTS option, the following screen displays:

If you selected the ISDN option, the following screen displays:
